# Home Inspection Report

# Building Inspection Report

## 1234 Your New Home, Your Town CA, 90000

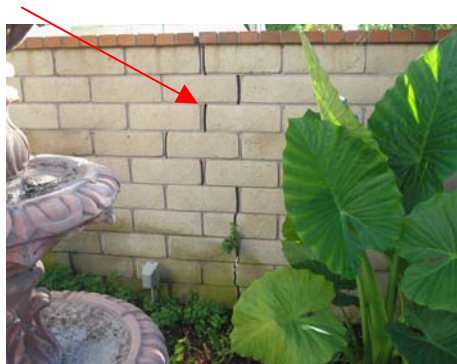
Walkway had some cracking, but is usable. Driveway had some settlement, but usable. Patio had some cracking and settlement, but was in usable condition. Fencing is not part of a home inspection. Fencing remarks do not constitute an inspection. Fencing was in need of maintenance repairs (palm trees appear to be damaging walls (E&W). Maintain a positive drainage slope away from the foundation. Faucets at BBQ Island are inoperative. Sink drains to planter.

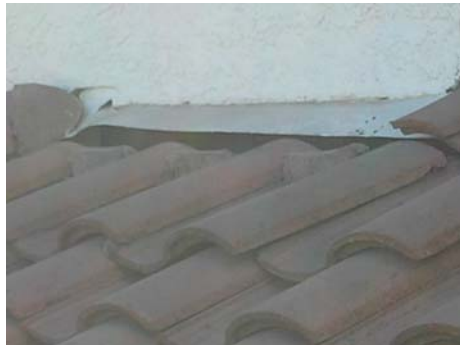
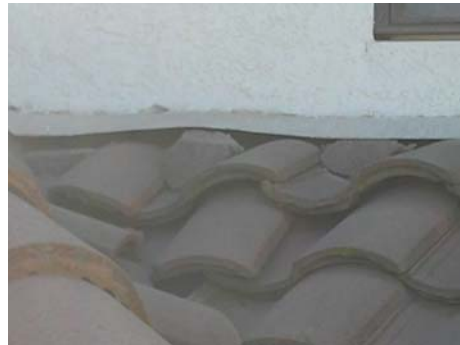
Roof inspection was limited to inspecting from the ground with binoculars due to material type. Roof inspection was limited to inspecting from the eaves due to material type. Roof covering showed signs of cracked/slipped tiles and will require repair/maintenance. There are slipped and cracked tiles over the garage. The mud seal is also cracked/slipped over the garage. Broken mud cap NE. Flashing missing around vent pipe N. Cracked tile N. Cracked mud cap SE at ridge.

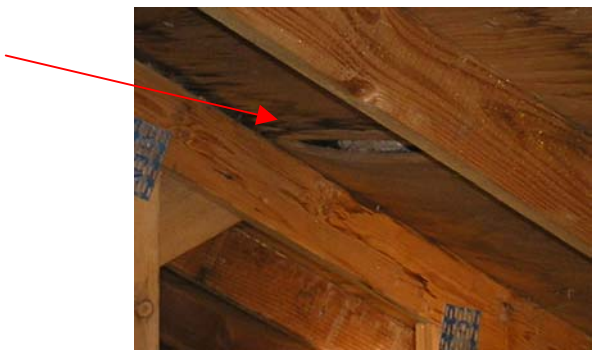
Change smoke detectors every 6 months. Trusses showed no major defects or damage at the time of inspection. Sheathing, examined from the attic, had some water damage, repair as needed (SE). This is likely where the water intruded that damaged the ceiling in the Master bath. Insulation was sufficient for homes in this area. Ventilation was normal. Bathroom exhaust fans appeared to be vented toward the exterior. Dry wall around scuttle hole entry is damaged. Aluminum windows of this type and age can be difficult to open and close- recommend cleaning tracks.

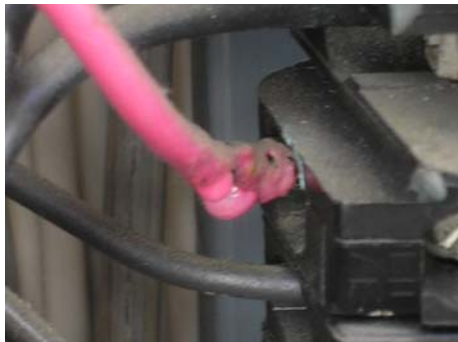
**General Comments:**  
 Panel size appeared to be compatible to service size. Panel was full and may need to be upgraded for future needs. Branch breaker distribution appeared normal. Signs of overheating were evident at the time of the inspection.

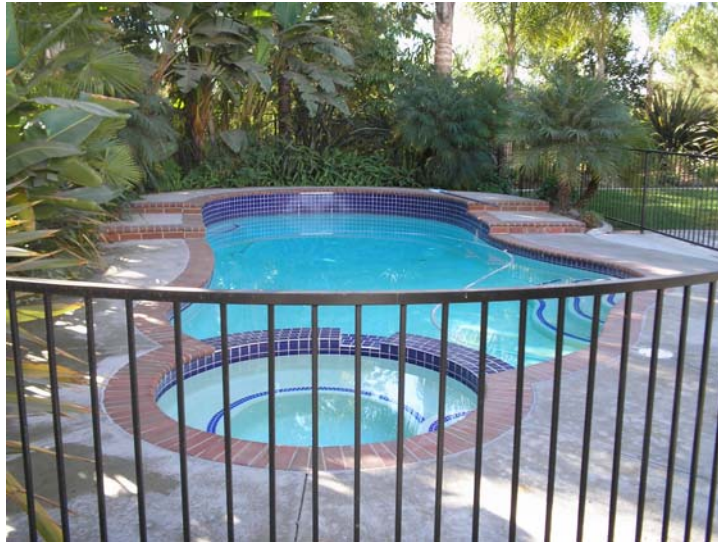
The pool/spa equipment is in fair condition. It will require some typical minor repair/improvements.
